Repair of the Tartan Ten, *Flags*

By Tony Sheppard, T&M Marine

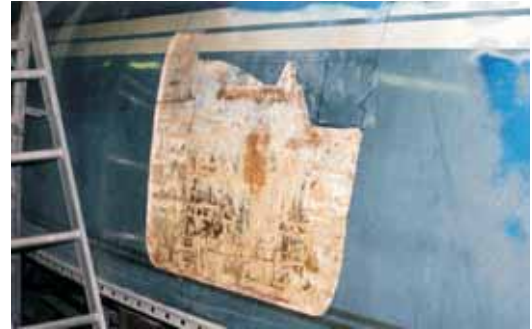
The boat is upside down and the outer skin and core have been removed with a router.

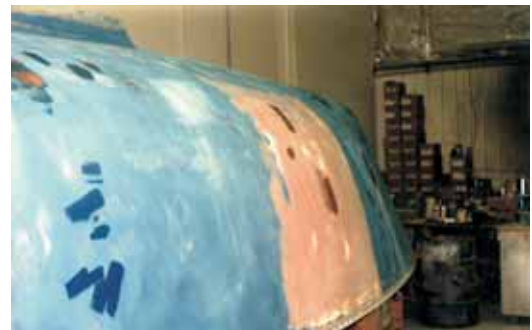
With new skin and core in place the repaired hull was faired before barrier coating and painting.

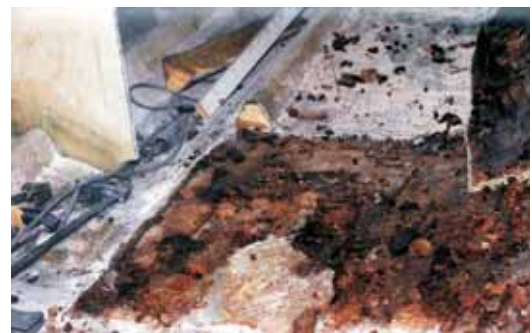
The interior floor skin and rotted balsa core were removed.

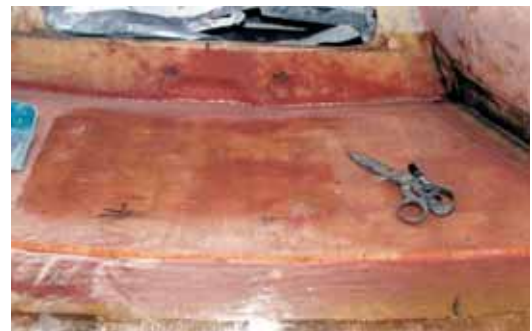
New balsa core and fiberglass skin were installed in the damaged areas.
